# Clearcreek Road Department

## Monthly Report

March 2026

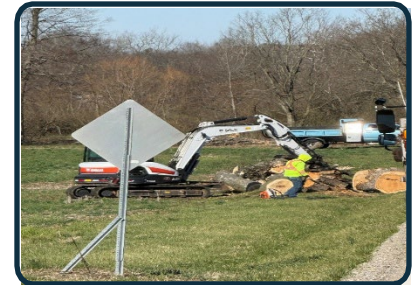
For the latter half of the month, work was concentrated at the park along Hoffmann Reserve's driveway. Heavy rainfall had rendered the driveway impassable for dump trucks and caused significant washout issues, including the failure of two culverts.

To address these issues, the following improvements were made:

- One culvert was replaced and upsized from a 20-inch pipe to a 24-inch pipe (30 feet in length).
- A second culvert was replaced and upsized from a 24-inch pipe to a 36-inch pipe (40 feet in length). The original pipe had deteriorated due to rust and was collapsing under traffic loads.
- A third culvert (15-inch diameter, 40 feet in length) was newly installed in an area that previously lacked drainage infrastructure. This addition was necessary to prevent water from overtopping the driveway and eroding the headwall.

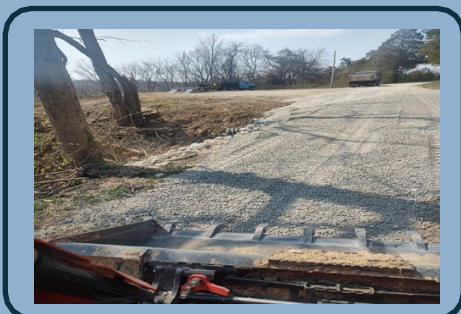
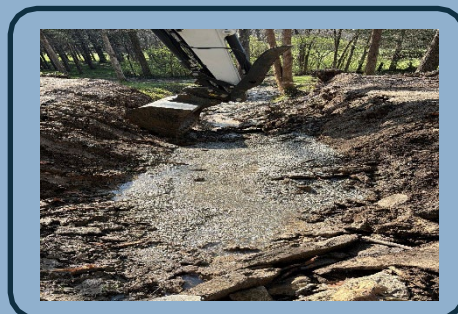
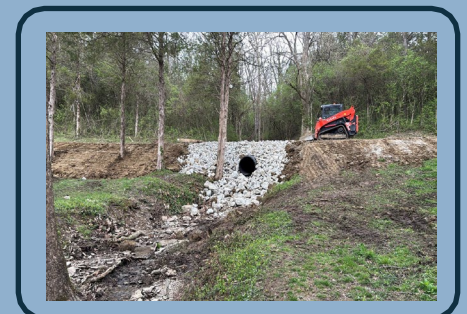
These improvements have restored safe access to the park and enhanced drainage to help prevent future washouts.

- 49 tons of riprap for pipe end stabilization
- 80 tons of No. 2 aggregate to build up the driveway base
- 192 tons of 411 aggregate to surface and restore the driveway
- 240 tons of fill dirt to complete grading beyond the driveway
